# Applying SOBANE Strategy for Risk Management in Museums

## Applying SOBANE Strategy for Risk Management in Museums

### *Short description of the case study: County Museum of Art «Baia Mare Artistic Centre»*

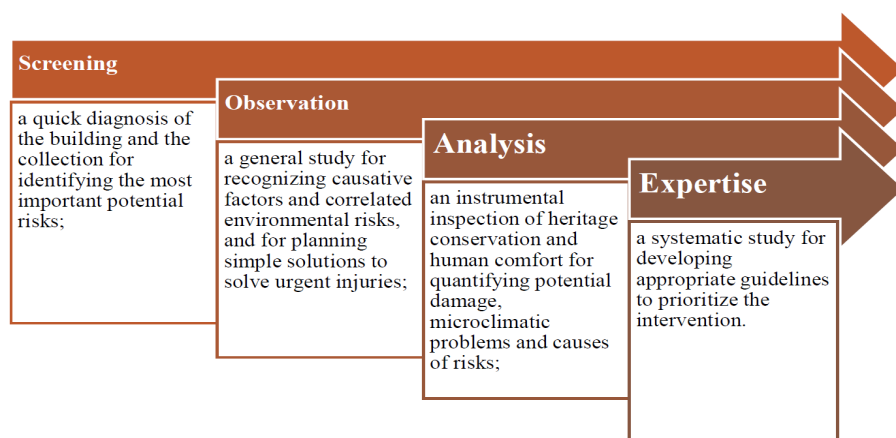
The results presented in this paper are part of a larger risk analysis conducted according to the “SOBANE strategy for environmental risk management in museum buildings” (Lucchi, 2020). The first step of the research was to perform “a quick diagnosis of the building and the collection for identifying the most important potential risks” (Lucchi, 2020). After that, the risk factors were prioritized and an analysis of their causes has been done. In the end, several measures and recommendations for reducing the potential damages caused by identified risks were proposed. Since temperature and RH fluctuations are among the factors with the highest probability of causing damages, a deep analysis of microclimate was carried out.

**Fig 1. The SOBANE strategy for environmental risk management in museum buildings**

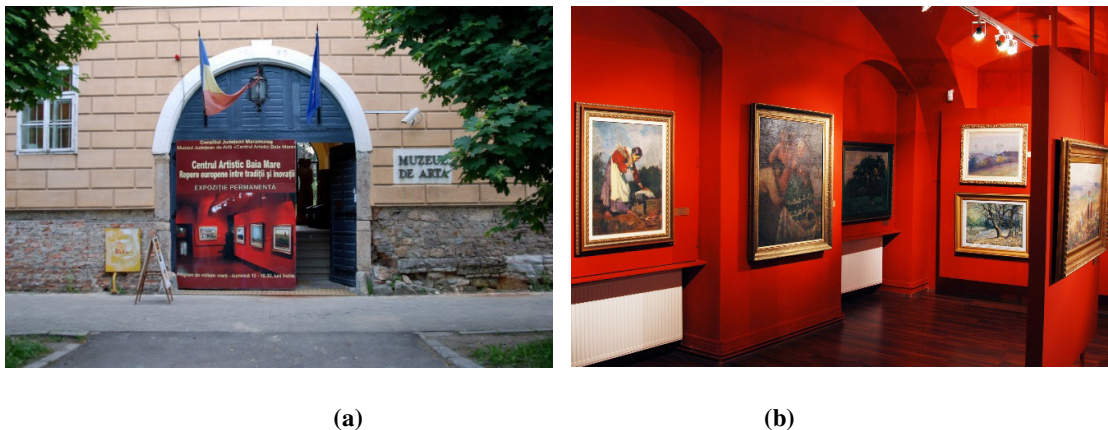
**Fig 2. County Museum of Art «Baia Mare Artistic Centre»: a) outside view b) inside view**

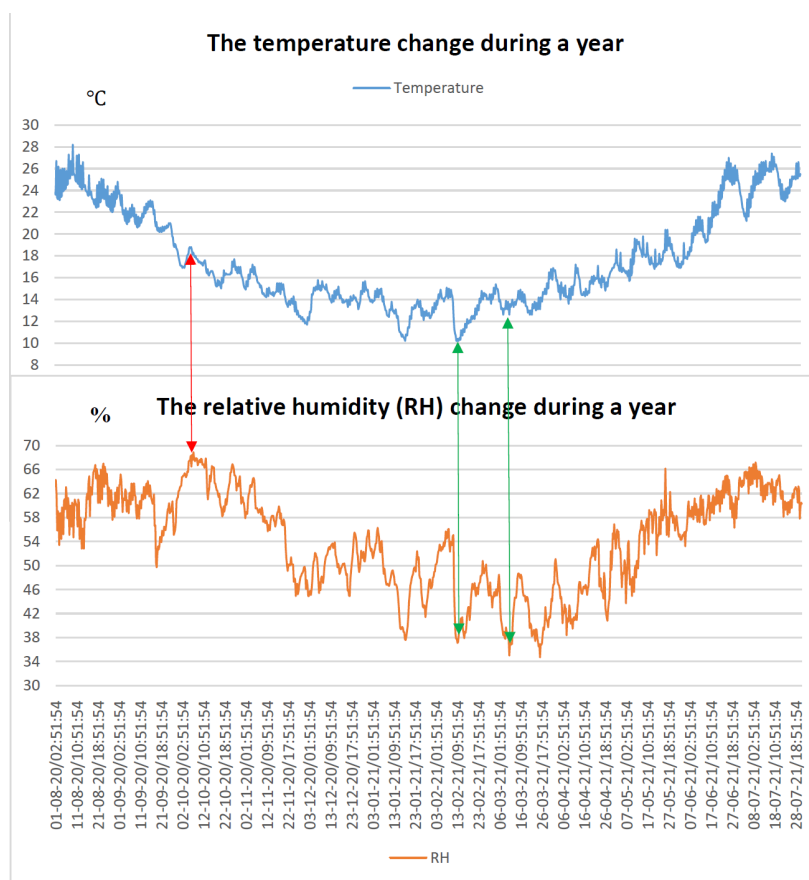
Figure 4 reveals that for most of the year the temperature in the warehouse does not exceed the value of 20 °C (October - June). Minimum temperatures drop to about 10 °C in winter, while in the warm season the temperature rises to about 28 °C. In total, there were 78 days in which the temperature was above 22 °C.

**Fig 4. The dynamics of the temperature and relative humidity in the time frame August 2020 – July 2021**

The second chart presented in Figure 4 shows that the RH does not usually exceed the maximum legal allowable value of 65%. Within a year, there were only 24 days in which the RH crossed this threshold. The highest values of this parameter were recorded in October, with a maximum of 68.9%, on October 7. The lowest values of RH are recorded in January-March, the minimum value reached being 34.7% (on March 25).

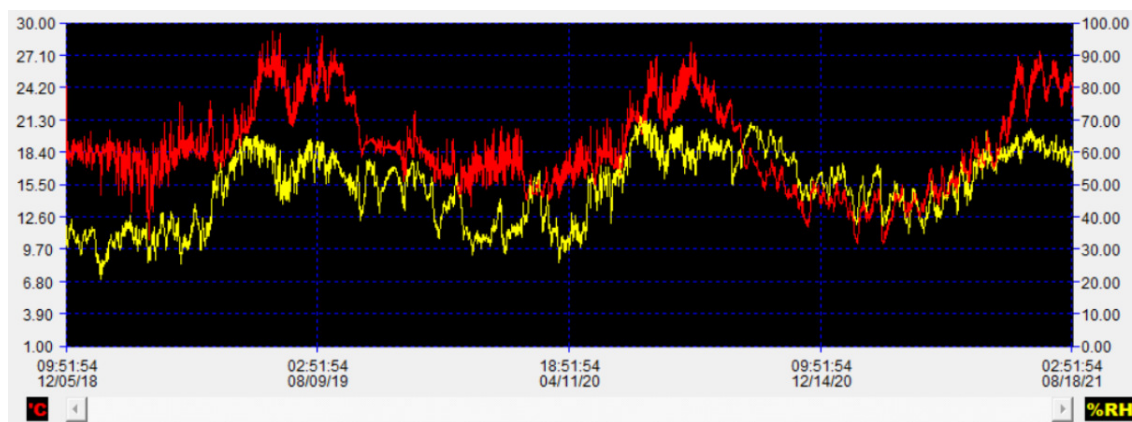
**Fig 5. Microclimate monitoring chart generated by the Datalogger application (December 2018 - August 2021)**

From the correlated analysis of temperature and RH dynamics we can see that in some cases (e.g., 13.01.2021, 13.02.2021) the decrease of RH happens concomitantly with the decrease of temperature. This is quite surprising if we take into account the fact that at a constant absolute humidity, the decrease in temperature causes the RH to rise and vice versa. Therefore, the evolution in the same direction of the two parameters can only be explained by the existence of a significant change in the absolute humidity in the warehouse. Specifically, the cold air entering the room had a lower absolute humidity than the previous absolute humidity in the room, which caused the RH to drop, despite the drop in temperature.

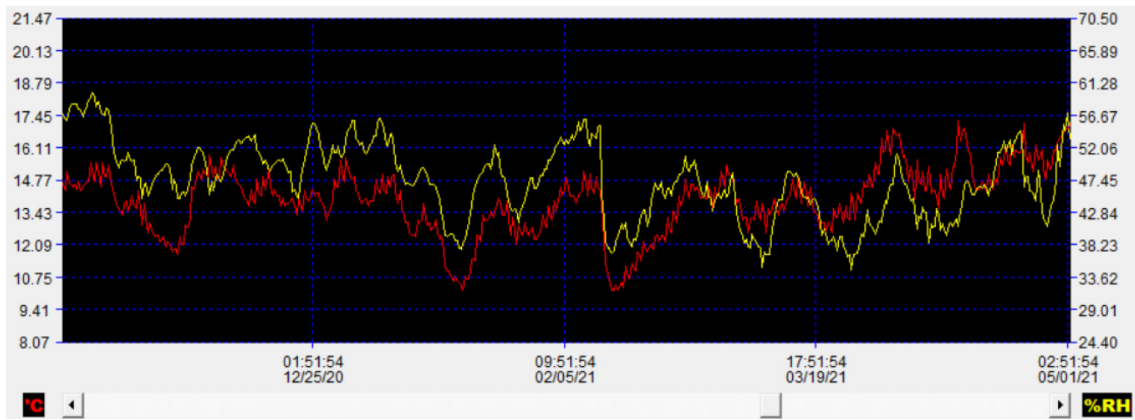
Based on these considerations, the radiator from the room was partially closed the following year. From Figure 7 it can be seen that this has led to a very similar trend of temperature and RH. Temperature usually ranged from 11-16 °C, and RH was in the range of 34% - 56%. The drop in atmospheric temperature has led to a drop in the RH because the water vapors in the air froze. When the outside temperature rose, this caused the snow to melt, which in turn led to an increase in humidity.

**Fig 7. The dynamics of temperature and relative humidity in the time frame November 2020 – May 2021**

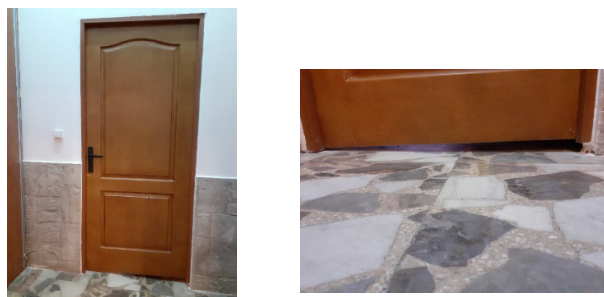
The main cause of temperature and RH fluctuations is that the warehouse operates in a space that was not originally designed for this purpose. Although the building that houses the warehouse has quite thick walls, this does not provide a very high degree of thermal insulation. Therefore, atmospheric fluctuations in temperature and humidity are felt quite quickly inside the warehouse. Heavy rainfall and evaporation of water from the soil in the hot season cause an increase in the RH in the deposit. In the cold season, the absolute humidity in the atmosphere is low, which means that there is a decrease in RH in the warehouse as well. It is also possible that a part of the RH fluctuation to be generated by the evaporation of water used for cleaning the floor of the hallways situated near the warehouse. As the entrance door has no threshold, water vapors can enter the storage room very easily.

**Fig 10. The warehouse entrance door**

- a) *Reducing the fluctuations of temperature and RH*, by: (1) reconditioning the storage window, so as to ensure a more efficient closing of it; (2) mounting a thick, opaque, thermally insulated panel on the inside part of the window; (3) replacing the entrance door with an airtight, fire-resistant door, or at least installing a sill to the existing door so as to prevent drafts, moisture and pests from entering inside; (4) thermal insulation of the warehouse; (5) installing an air conditioner device for keeping temperature and RH at a low level during summer; (6) using buffer materials which absorb moisture much faster than the cultural objects (silica gel, magnesium nitrate, sodium bromide) (Capotă, 2021);

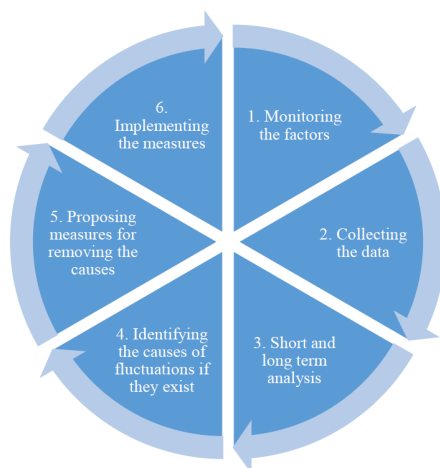
**Fig 11. The process of microclimate risk management in museums**

Many times, treating the symptoms of a disease has only a short-time benefit. Without finding and eliminating the causes of the disease, the problem is not completely solved and the patient will probably be sick again after the treatment ends, if the cause is still there. The same happens with the cultural heritage. If we wait until RH is too low or high, and, in that moment, the only thing we do is to use humidifiers / dehumidifiers, besides creating a high fluctuation of the parameter which is harmful for the collection, we do not really solve the problem because the incorrect RH will occur again after we stop the “treatment”. Thus, for a proper microclimate risk management of the collection, the steps presented in figure 11 should be followed.
